# **Pavement Conditions**

Present Serviceability Rating - PSR Per National Standard Rating Adjusted for RuttingSystem Based on Pavement Profiler Data Collected August - October 2002

Map Compiled January 2003 by Statewide Pavement Management, Design and Engineering Services, State of Alaska DOT&PF

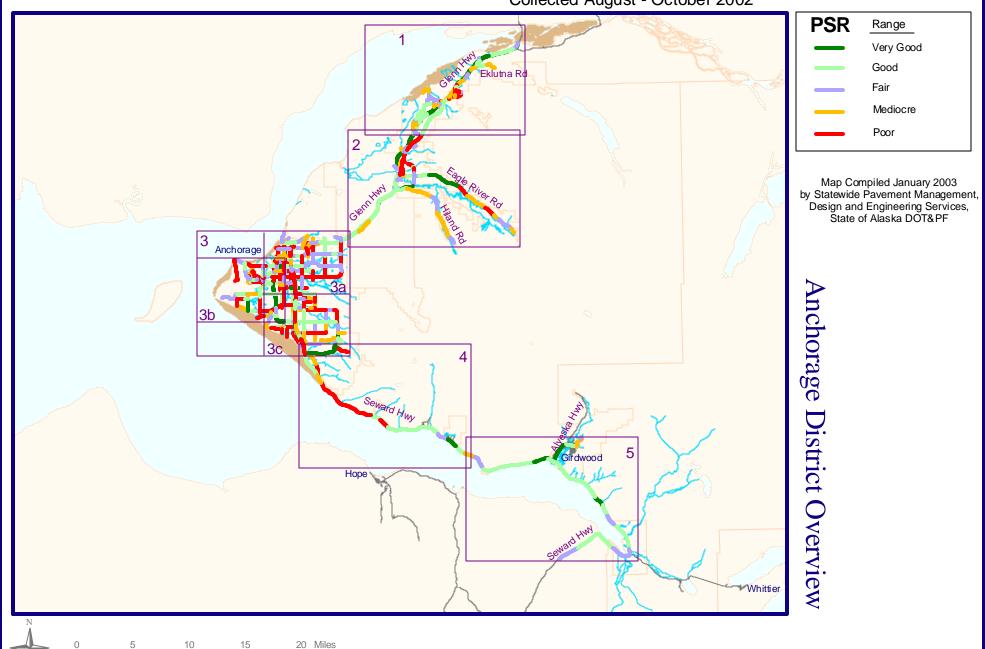
Present Serviceability Rating - PSR
Per National Standard Rating Adjusted for RuttingSystem
Based on Pavement Profiler Data
Collected August - October 2002

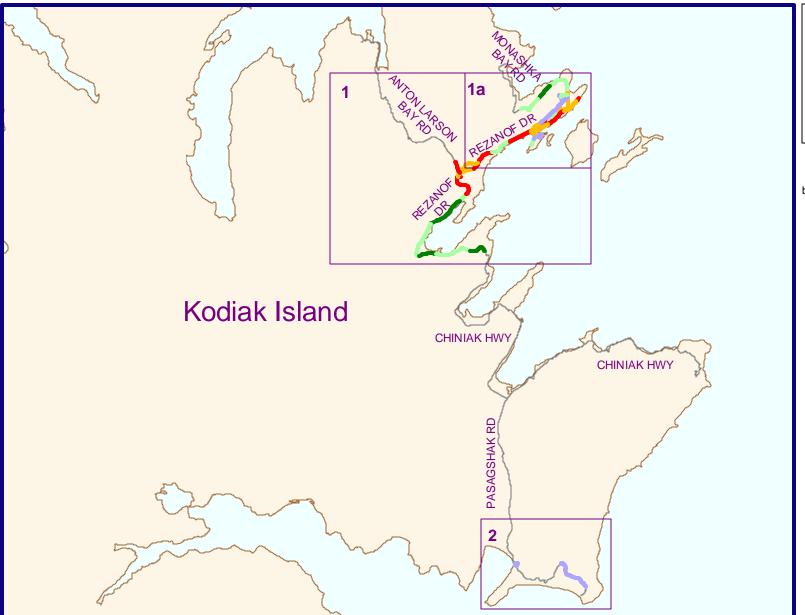
Kodiak Island Overview

Present Serviceability Rating - PSR Per National Standard Rating Adjusted for RuttingSystem Based on Pavement Profiler Data Collected August - October 2002
